**AN EVALUATION OF
CONSERVATION AND REHABILITATION STUDIES IN HISTORICAL AREAS
WITHIN THE SCOPE OF RESILIENCE:
CASE OF HAMAMÖNÜ AREA IN ANKARA**

MASTER OF ARCHITECTURE

Rabia ÇAKIROĞLU

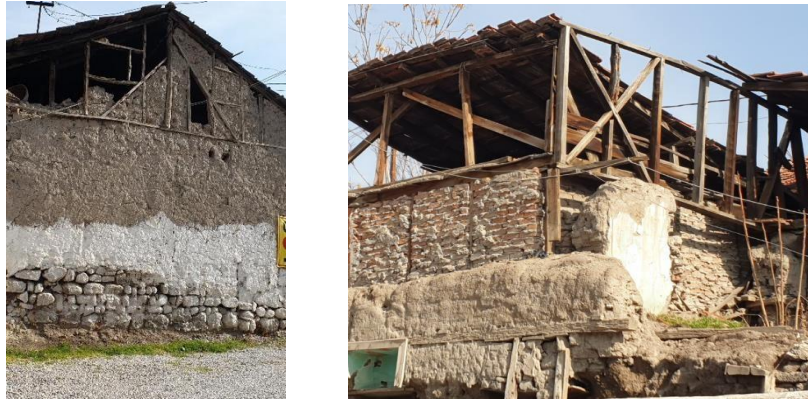
Figure 3.5: Structural system details from the houses at Dutlu and Sarıkadı Streets (Çakıroğlu, 2021)

According to the Şahin Güçhan, 'the masonry base, which is usually composed of the ground floor and foundations, is made entirely of stone or stone and mud brick according to the local conditions. In some earlier houses in Ankara, in Beypazarı,' The first layer used as a basis, the second layer of the buildings which are the main walls of the ground and upper floor are built with mudbrick. The wooden lintel and 'Timber lintels, which are secured with tie beams, are placed on the inner and outer surfaces of the main walls' (Şahin Güçhan, 2017:14). The dwelling at Dutlu Street no. 21 (Figure 3.6, Figure 3.7, Figure 3.8) represents a significant example to understand the general typology of traditional residential architecture in Ankara, as it shows the common use of the materials such as; wood, stone, mudbrick, and roof typology as a hipped roof covered with 'alaturca' type of tiles (Tunçer, 2002). Narrow vertical-sliding windows which are mostly used on the upper floors to provide light and view, and are more suitable in terms of privacy with wooden material also show authenticity. Types of structural supports under the projections are sometimes of *eliböğründe* type or 'ahşap bindirme' in the Hamamönü region (Arslan, 2012: 92). Two-story,(Figure 3.5 and 3.6) three-storey (Figure 3.9 and 3.10), and rarely single-story high residential buildings are located and shaped according to the topography and the environmental relations of the parcel with its surrounding. All the buildings in one parcel are built to be used by one extended single-family.

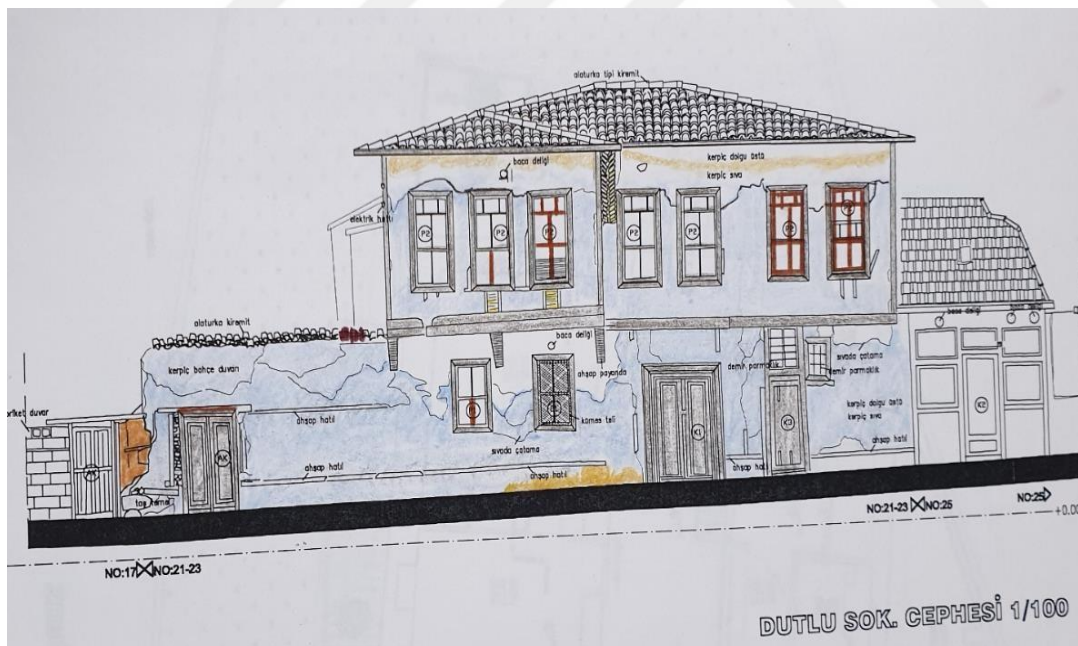
Figure 3.8: Elevation of the house at Dutlu street no: 21 (Önen 2000).

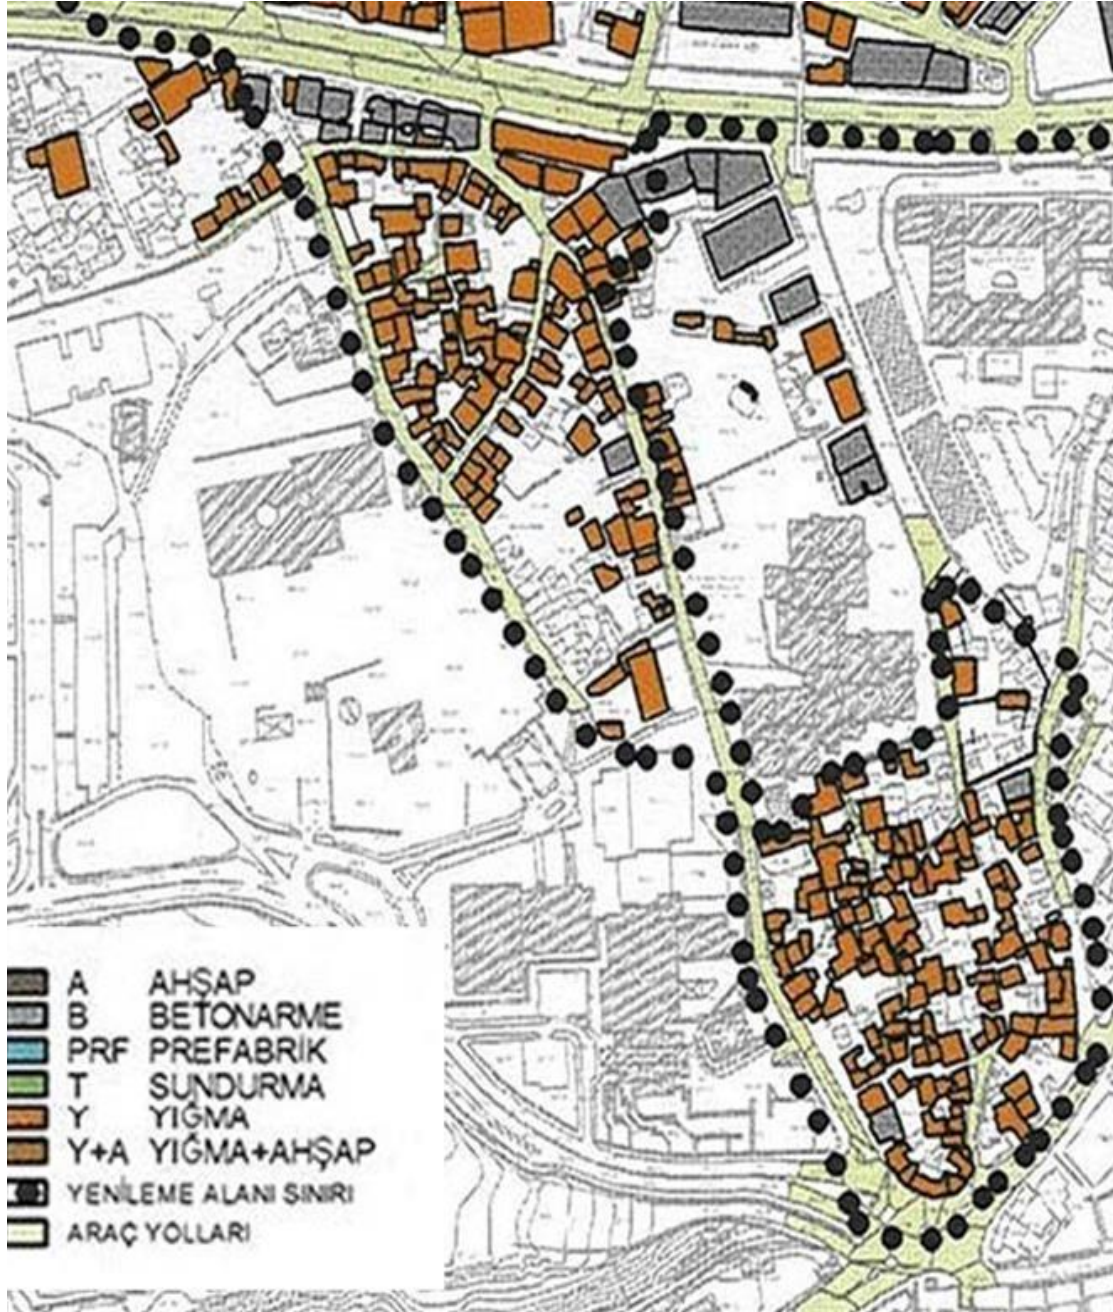
Figure 3.12: Analysis of Structural Systems and Materials of Buildings in the study area before the Rehabilitation Project (Metropolitan Municipality Archives, 2006, access date: 2020)

Even though the general material tendency has changed, the research shows that until 2006 the main housing typology of Hamamönü remained original.

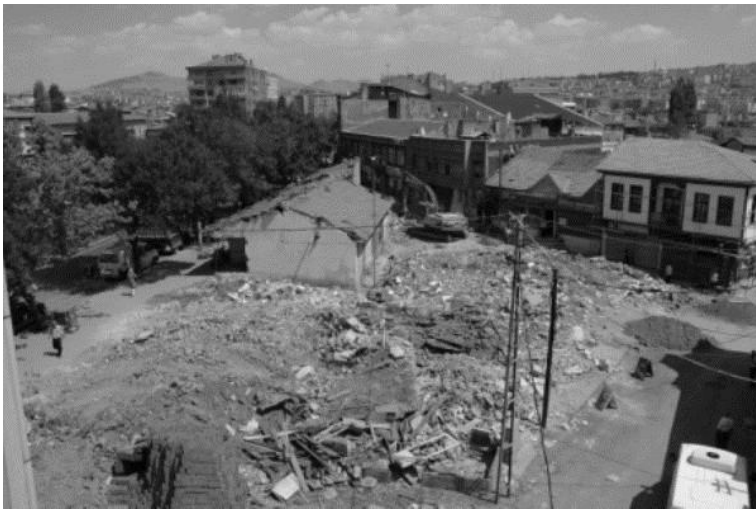
Figure 3.13: View from M. A. Ersoy Street in 2006 showing the collapsed buildings due to negligence in the study area (Arslan, 2012)

After a decade, the urban fabric of Hamamönü started to change irrevocably. As seen in the photographs Figure 3.13 and Figure 3.14, the deteriorations, deformations, and destructions of the original materials and the structures of the aging historic buildings, as well as the later period additions, caused many conservation problems. Problems at the plasters on the facades, at the mortars as bonding materials, architectural elements like windows/doors, and others are seen frequently. Spatial organizational changes caused by the usage, is one of the most common physical problems of the buildings at Hamamönü. These changes in the buildings caused irreversible losses of original qualities (Büyüköz, 2019: 10).

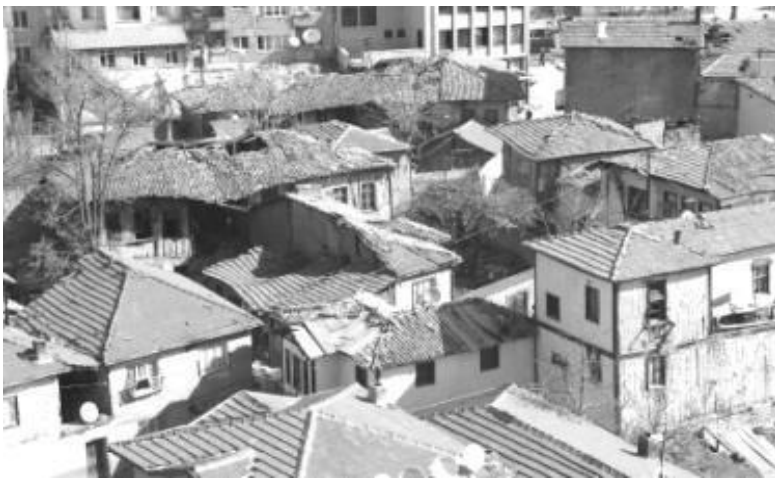
Figure 3.14: View from Hamamönü quarter 2006 in the study area (Arslan,2012)

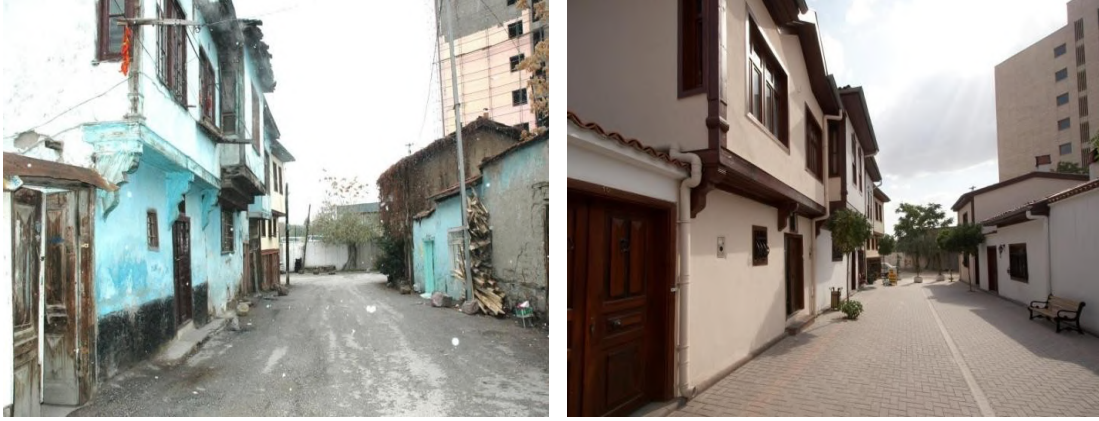
Figure 3.27: Before and after views of Dutlu Street (Yabacı, 2012)

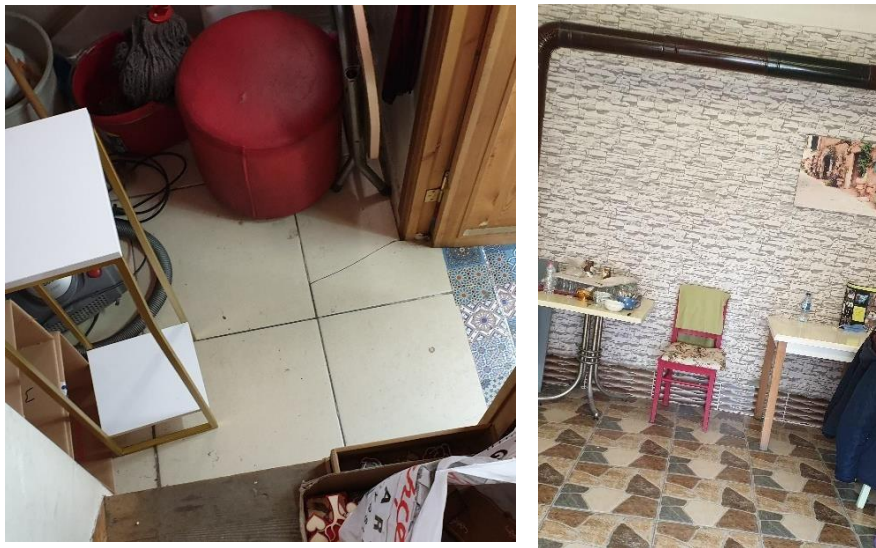
Figure 3.30: Examples of material variety at the interiors of the buildings on Dutlu Street (Çakıroğlu, 2021)

Dutlu Street is quite close to the Hacettepe University Campus and there were no lodgings and residential buildings within the campus area were mainly replaced by the dormitory library and the hospital buildings. There were no social or cultural centers that would attract young people around. The rehabilitation project, considering just the exteriors, encouraged the dwellers to restore the interiors of their houses, but several difficulties such as multiple ownerships and financial problems made that impossible. Before the projects were sent to the council for approval, the owners and the tenants of the buildings in the area were invited to the municipality by notifications (Yabacı, 2012: 55). Approval of the dwellers was not sufficient for a participatory project. Also, they could not afford proper improvements in terms of conservation, cheap and improper materials were used in several cases (Figure 3.30).

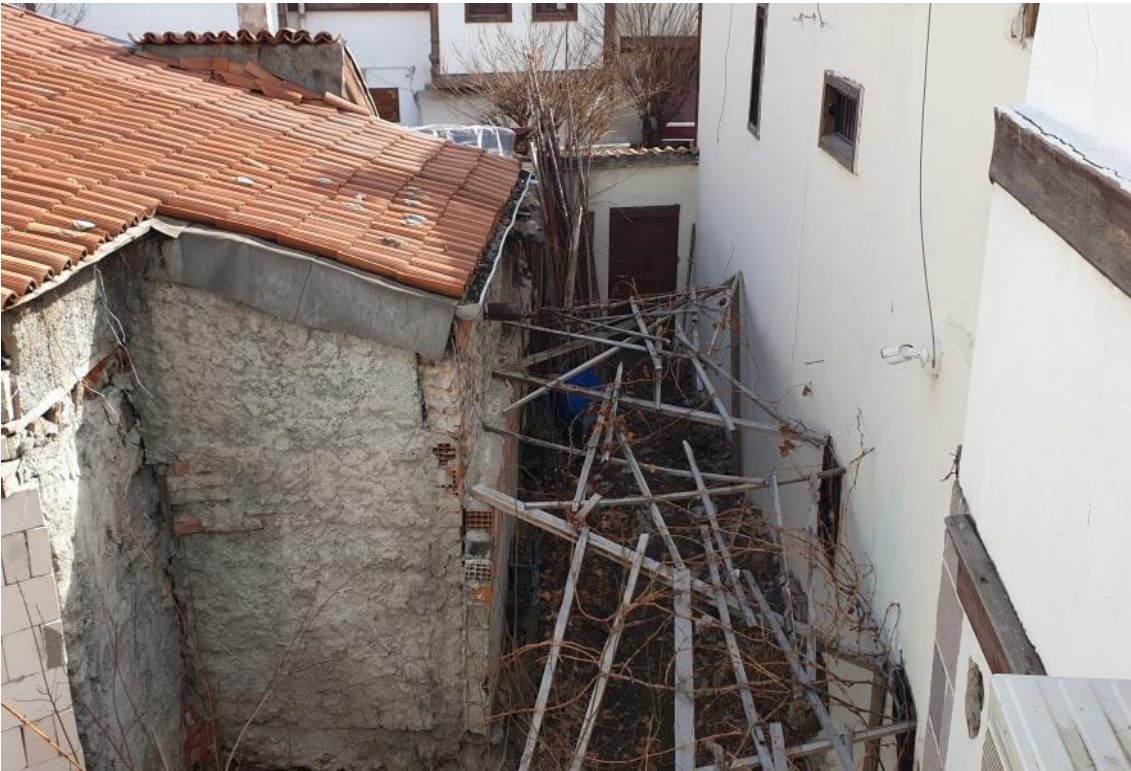
Figure 3.47: An example to the use of incompatible materials for the repair of old buildings at Hamamönü (Çakıroğlu, 2021)

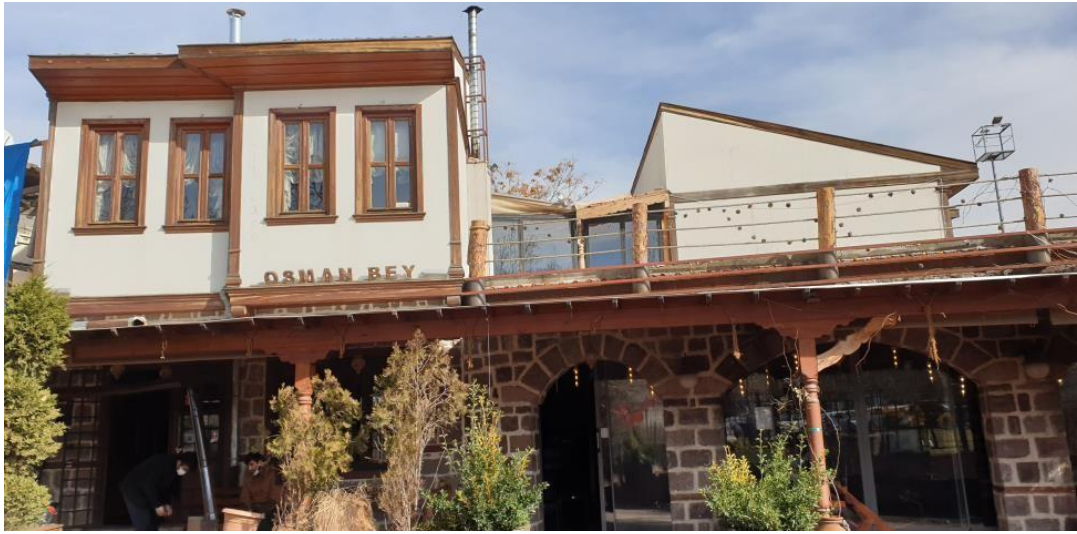
Figure 3.48: Building annexes, incompatible with the traditional characteristics (Çakıroğlu, 2021)

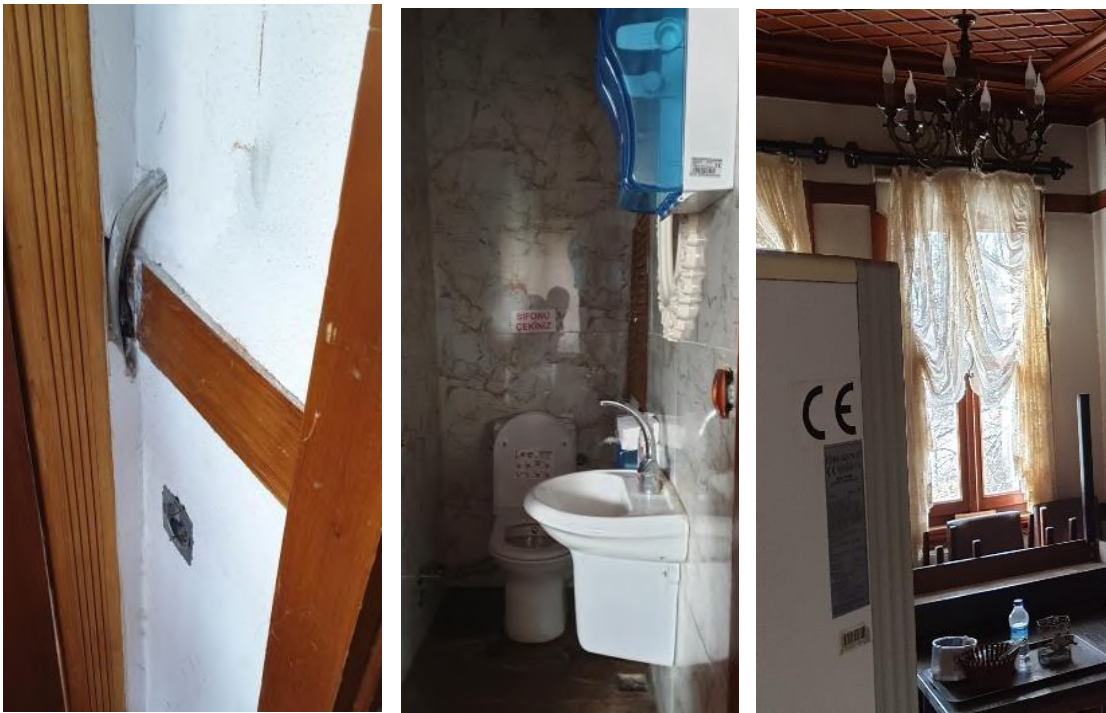
Figure 3.50: New interventions to the historic buildings (Çakıroğlu, 2021)

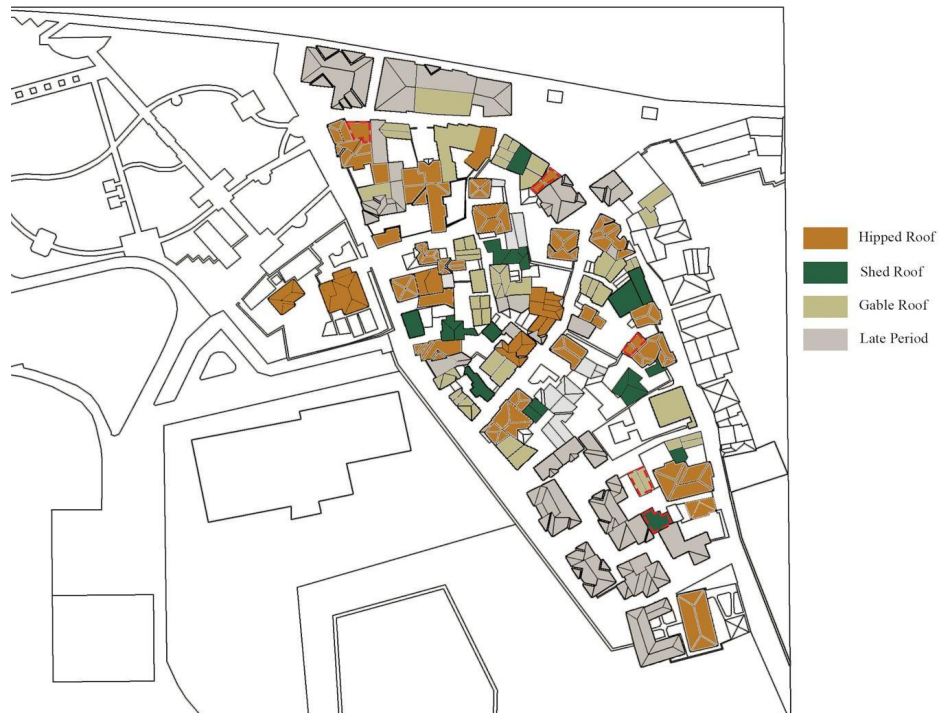
Figure 4.6: Renovated Roofs (Çakıroğlu, 2021)

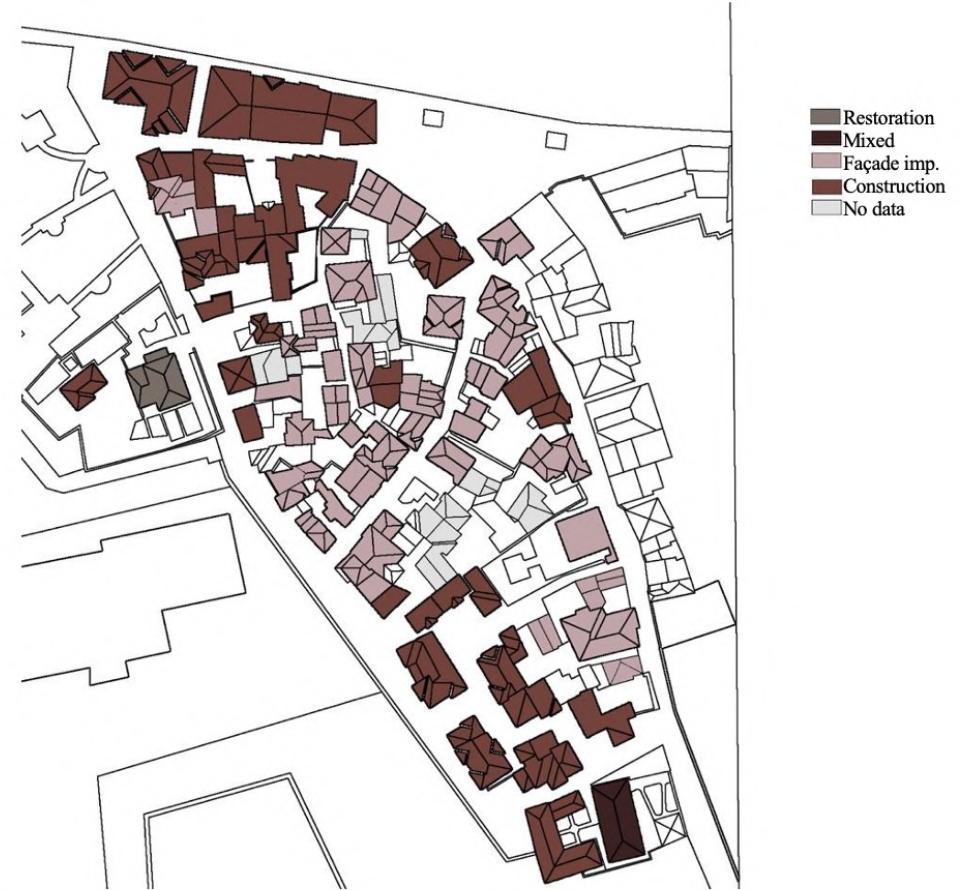
Figure 4.9: Comparative Structural and Material Conditions of the Buildings in Hamamönü (Left) Before the 2006 (Altındağ Municipality Archives, 2020), (Right) Current conditions of the buildings in 2021 (Çakıroğlu,2021)
